Manhole Inspection Summary

Manhole # S51O__042MH

Insp Date: **4/23/08 1:47 PM**

Location Address: **2701 boston street**

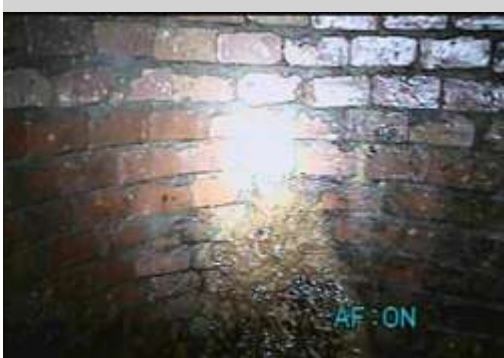
Defect 3

Infiltration: ☐ None ☐ Joint ☐ Cracks ☐ Mortar ☐ Roots ☒ **Wall**

barrel wall infiltration

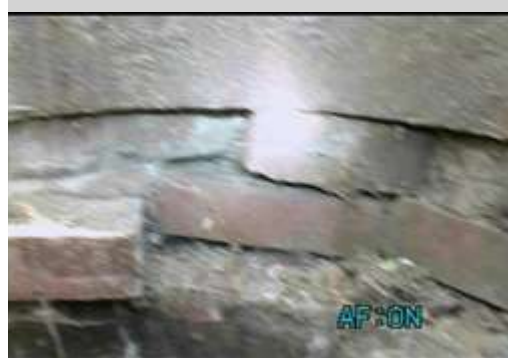
Defect 2

Condition: ☐ Sound ☐ Cracked ☐ Root Intrusion ☒ **Loose Brick** ☐ Deteriorated

chimney loose bricks

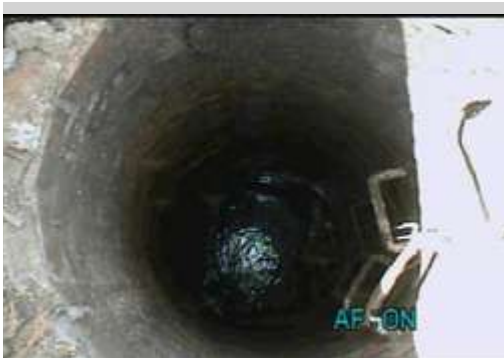
Defect 1

Steps Count: **14** Missing: **0** ☒ **Corroded**

Surcharge ☒ **Evidence Of Surcharge** Depth: **6** (ft.) ☐ Active Surcharge Present

steps corroded and surcharge evidence
